Third Time's A Charm

Sean Park, Central Metal Finishing Inc.

In a metal finishing facility, wastewater management is critical. Often, seemingly small issues can shut down the entire cycle. Now on its third generation of pumps, this metal finisher has finally found a solution to its wastewater treatment issues.

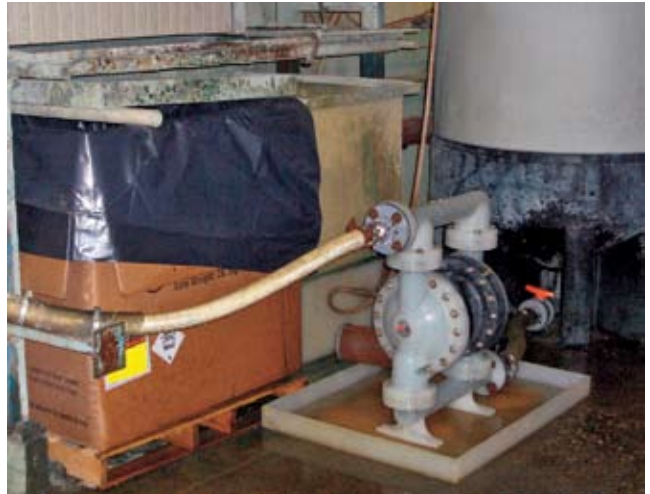
The rinse waters at CMF contain nickel, zinc and other acidic metals. After these rinse waters are treated and their chemistries adjusted to a neutral pH level, evaporators boil off the remaining water.

In a metal finishing facility, wastewater management is critical. Often, seemingly small issues can shut down the entire cycle. Providing a variety of finishes and coatings, CMF rinse waters contain nickel, zinc and other acidic metals. After these rinse waters are treated and their chemistries adjusted to a neutral pH level, CMF evaporators boil off the remaining water.

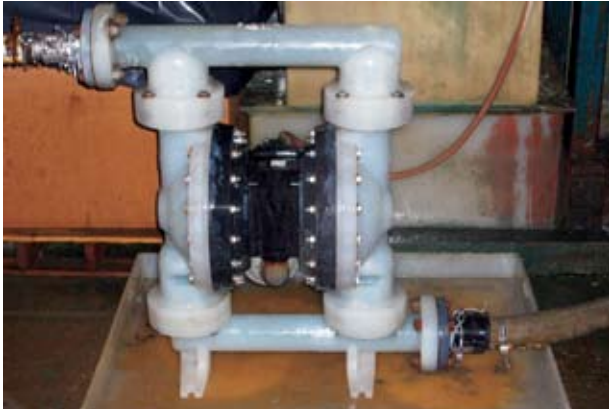
CMF trialed this 2-in non-metallic diaphragm pump as a loaner for 60 days. Because it withstood a tremendous amount of abuse without a single issue, the facility kept it.

I met with David Carson, the director of industrial sales for Burt Process Equipment (Hamden, CT), and explained our situation. Carson offered to loan CMF a 2-in non-metallic Ingersoll Rand ARO EXPert™ diaphragm pump to use in place of our current pump for 60 days. Tired of rotating failing

The pump withstood a tremendous amount of abuse, without a single issue. It worked well enough that our general manager didn't even want to purchase a new one, so we just kept the loaner.

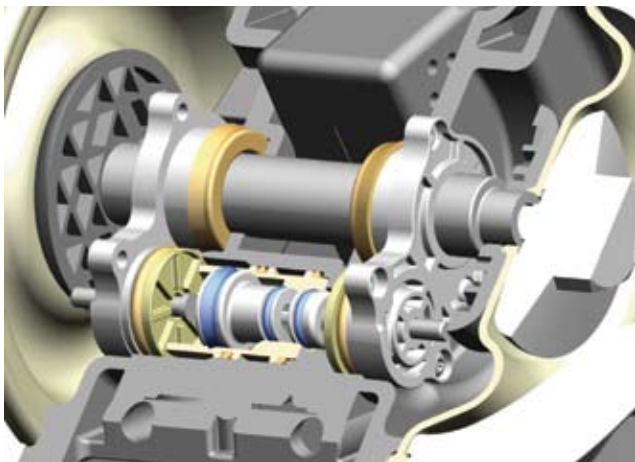
The new pump CMF installed uses an unbalanced valve design to eliminate valve centering and pump stall-out, even under low air inlet pressures.

"This new pump utilizes a positive seal on the valve spool created by 'U-cups' to ensure maximum efficiency," explains Carson. "The simple but rugged design almost completely avoids air blow-by."

Pumps also stall frequently in wastewater applications because of poor motor technology. Many pumps feature a "balanced" air valve design that allows the valve to center under low air inlet pressures, preventing a complete positive shift and stalling the pump. In filter press applications where pressure is constantly increasing, a "straight-spool" design often spells pump trouble.

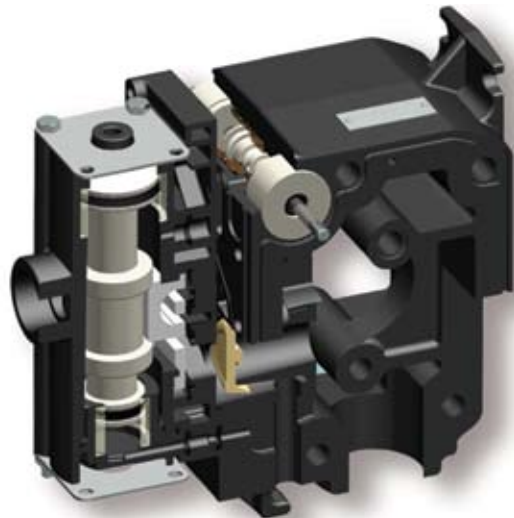
The new pump CMF installed is able to remove wet, cold air and send it through the exhaust. This means extra equipment is not necessary to thaw the motor because it takes care of itself.

Freezing is another chronic problem in wastewater applications, causing the motor to seize up and fail. Compressed air turns extremely cold as it returns to atmospheric pressure, allowing moisture with the air supply to freeze. These ice particles accumulate, clog the exhaust port and stall the pump. To combat this problem, many facilities implement space heaters, hot water taps and other thawing mechanisms.

"A Quick Dump™ feature on this new pump removes wet, cold air and sends it through the exhaust," says Carson. "Operators don't need extra equipment to thaw the motor, because it takes care of itself."
